Manhole Inspection Summary

Manhole # S51M__028MH

Location Address: **2844 s. linwood**

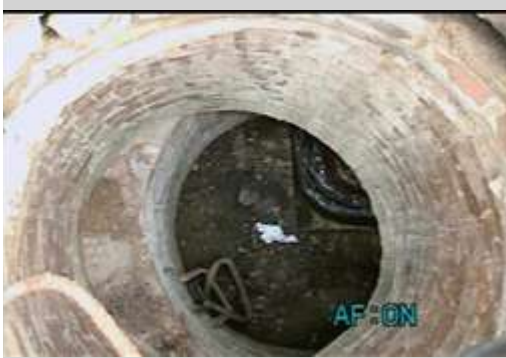
Top View

Frame Offset: **0** (in.) Condition: ☐ Sound ☒ **Cracked** ☐ Leaks

Condition: ☐ Sound ☐ Cracked ☐ Root Intrusion ☒ **Loose Brick** ☐ Deteriorated

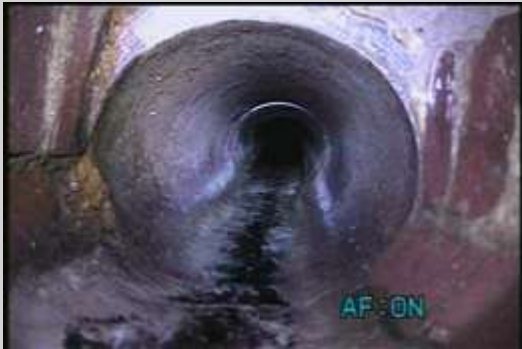
12 O'Clock Outflow

8 in. Circular Gravity Sewer
Pipe Out @ 12 O'Clock

Pipe Material: **Clay** ☐ Pipe Lined

Invert Depth: **8.96** (ft.) Flow Characteristics: **Fast**

Deposits: ☒ None ☐ Mud ☐ Sludge ☐ Debris ☐ Grease

Infiltration: **None** Pipe Seal Cond: **Unknown**

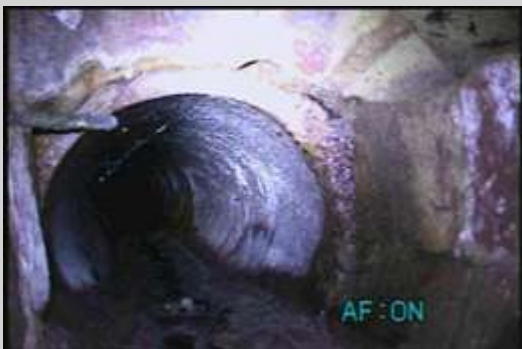
3 O'Clock Inflow

8 in. Circular Gravity Sewer
Pipe In @ 3 O'Clock

Pipe Material: **Clay** ☐ Pipe Lined

Infiltration: **None** Pipe Seal Cond: **Unknown**
